Test Report

No.: ETR22C00484

ESCORT SEAL CO., LTD.

Test Requested : As specified by client, to test Halogen-Fluorine, Chlorine, Bromine, Iodine in the submitted sample.

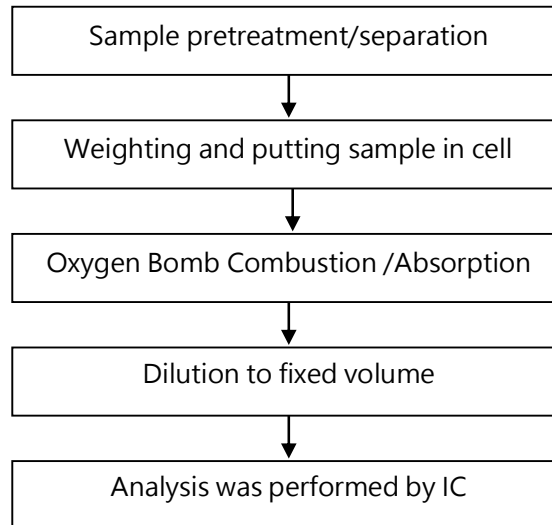
Analytical flow chart of Halogen

Test Item(s)	Method	Unit	MDL	Result
				No.1
Fluorine (F) (CAS No.: 14762-94-8)	With reference to BS EN 14582: 2016, analysis was performed by IC.	mg/kg	50	78.2
Chlorine (Cl) (CAS No.: 22537-15-1)	With reference to BS EN 14582: 2016, analysis was performed by IC.	mg/kg	50	1750
Bromine (Br) (CAS No.: 10097-32-2)	With reference to BS EN 14582: 2016, analysis was performed by IC.	mg/kg	50	n.d.
Iodine (I) (CAS No.: 14362-44-8)	With reference to BS EN 14582: 2016, analysis was performed by IC.	mg/kg	50	n.d.

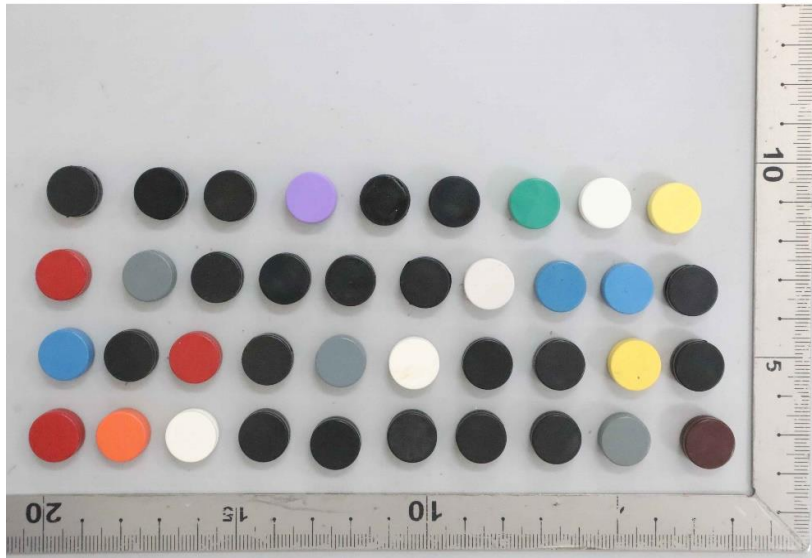
ETR22C00484

* The tested sample / part is marked by an arrow if it's shown on the photo. *
