Test Report

No.: ETR24704602

ESCORT SEAL CO., LTD.

Test Requested : As specified by client, to test Halogen-Fluorine, Chlorine, Bromine, Iodine in the submitted sample.

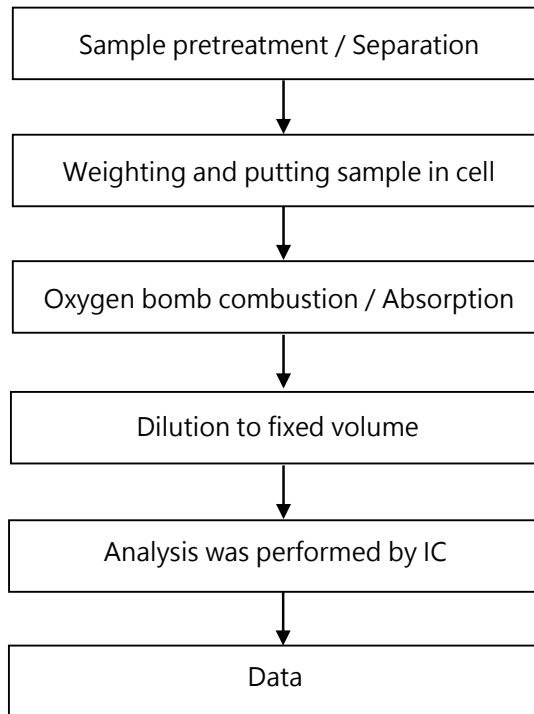
Analytical flow chart - Halogen

Test Item(s)	Method	Unit	MDL	Result
				No.1
Fluorine (F) (CAS No.: 14762-94-8)	With reference to BS EN 14582: 2016, analysis was performed by IC.	mg/kg	50	n.d.
Chlorine (Cl) (CAS No.: 22537-15-1)	With reference to BS EN 14582: 2016, analysis was performed by IC.	mg/kg	50	853
Bromine (Br) (CAS No.: 10097-32-2)	With reference to BS EN 14582: 2016, analysis was performed by IC.	mg/kg	50	n.d.
Iodine (I) (CAS No.: 14362-44-8)	With reference to BS EN 14582: 2016, analysis was performed by IC.	mg/kg	50	n.d.

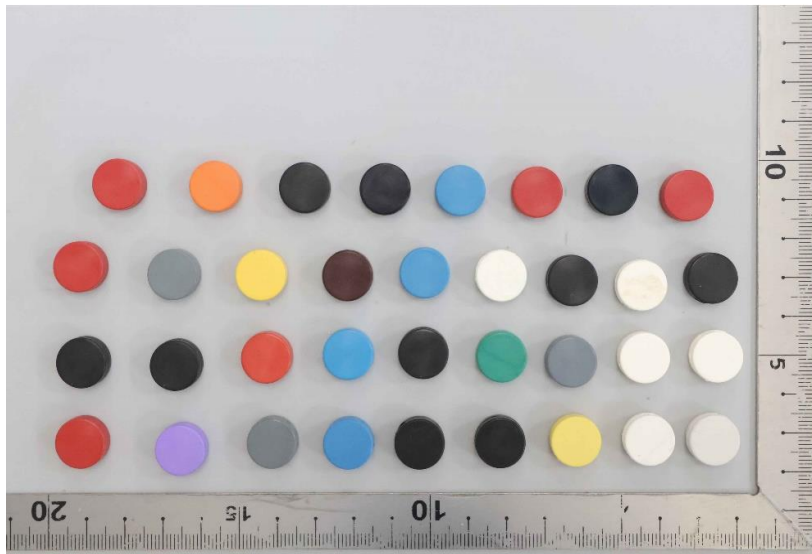
ETR24704602

* The tested sample / part is marked by an arrow if it's shown on the photo. *
